BURNABY SUPERMARKET ROOFTOP PARKING DECK

Structural Analysis
Beam Failure Example

I35W Bridge Collapse

Structural Analysis

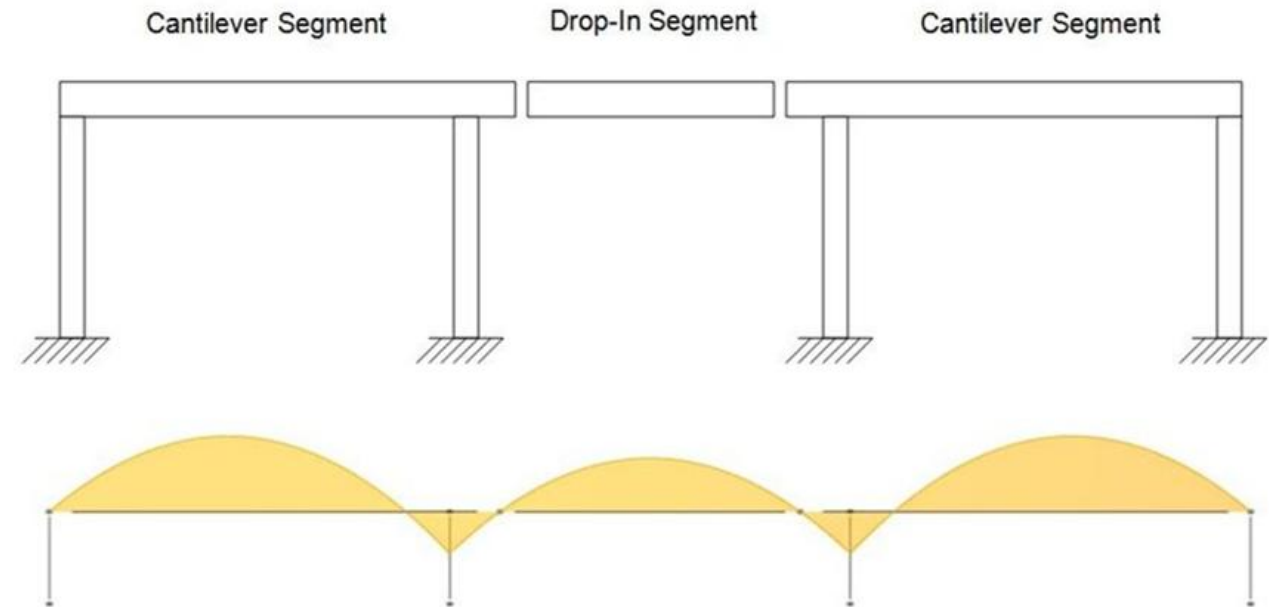
- Design: Steel column and beam structure
 - Cantilevered or Gerber beam system

Composite concrete and corrugated metal deck

Open-web steel joists

Wide-flange steel beams passed over hollow steel tube columns

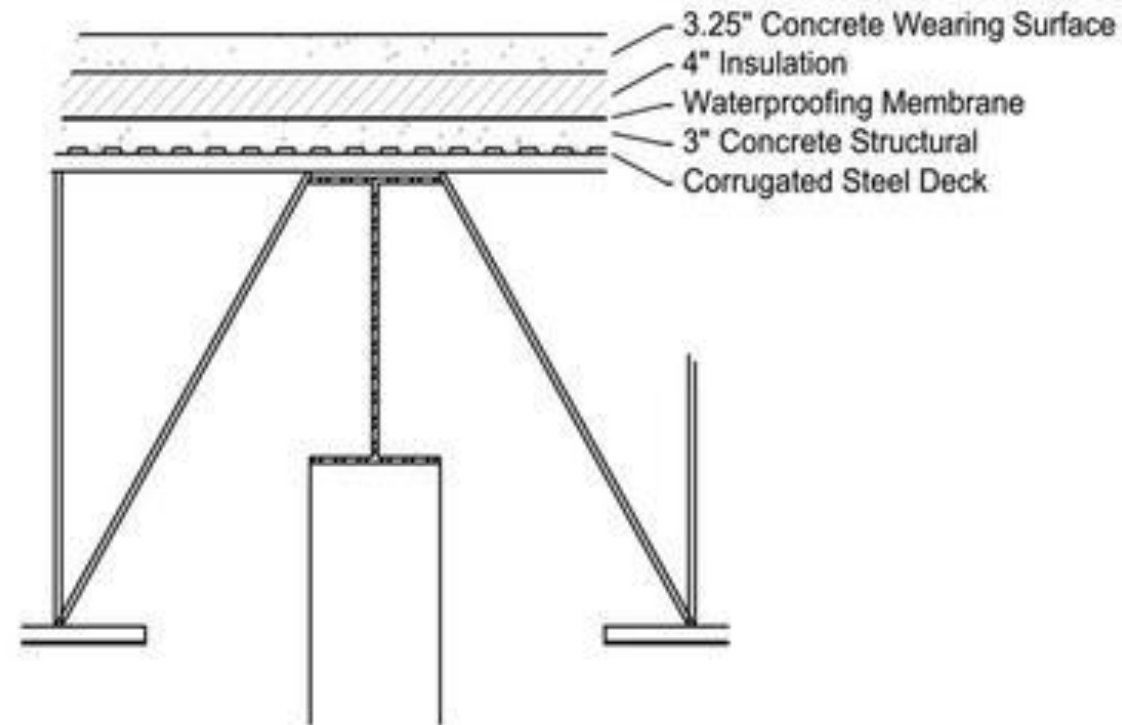
- Rooftop
 - Parking for customers
 - Roof Cross Section (Right)

Top-Slab Wearing Surface

Light Styrofoam Insulation

Waterproofing Membrane

3" Concrete

Corrugated Steel Deck

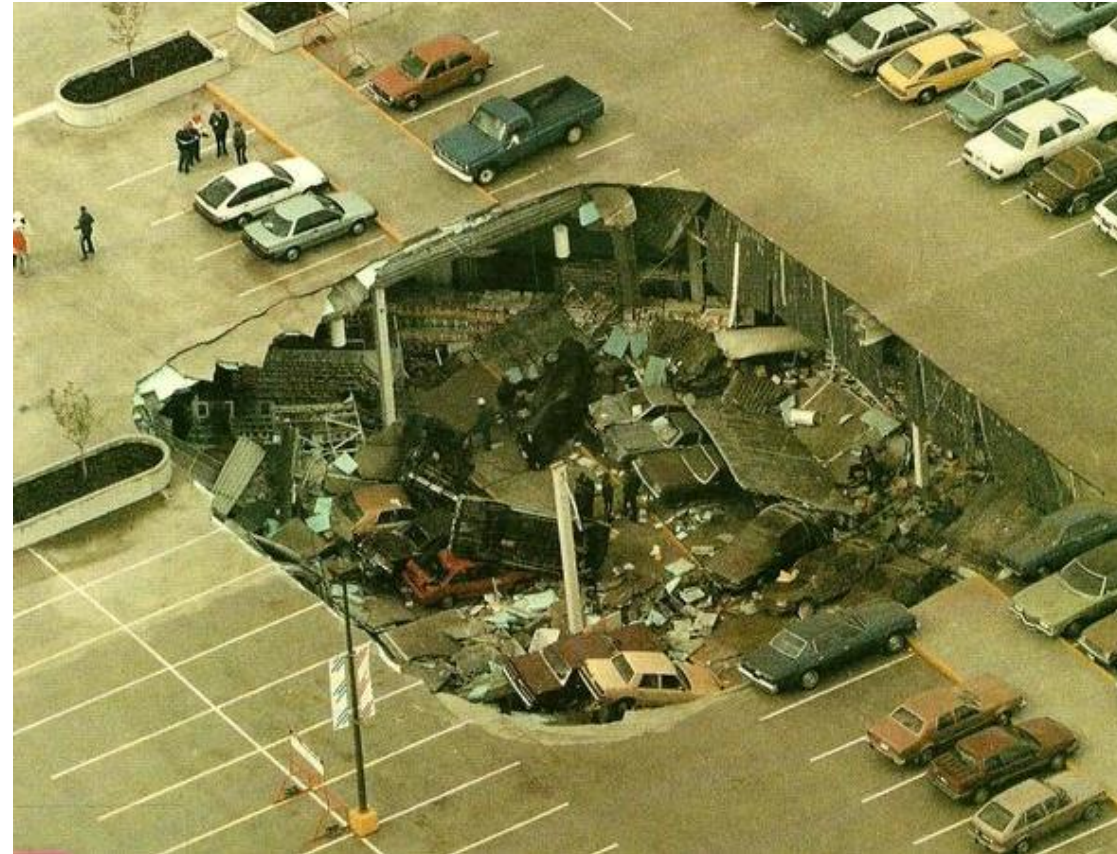
- Collapse: April 23, 1988 – Grand Opening Ceremony
- Signs of Failure:
 - A loud bang was heard
 - Water flowing from a broken overhead pipe
- Evacuation Began
- Roof collapsed into shopping area
 - Collapsed Area: 87 by 75 ft.
- 21 people injured
- 20 cars destroyed

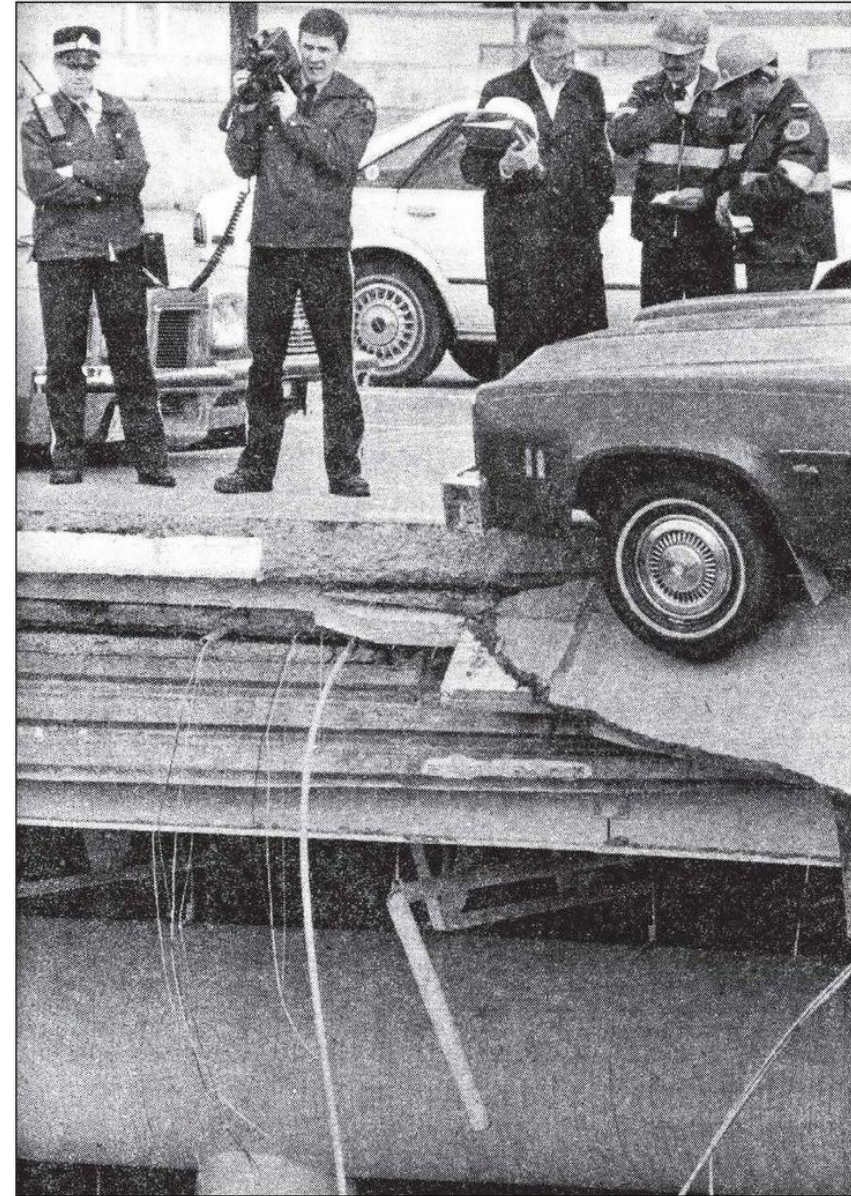
Police and fire officials inspect the damage after a rooftop parking ramp collapsed into a crowded Save-On Foods store at Station Square in April 1988. All construction on the \$75-million mall project was shut down during a investigation of the event, which saw part of a parking lot located on the roof of the supermarket cave in, sending parked cars and debris plunging into the store. An estimated 1,000 people were in the store. Fifteen people, including then-mayor Bill Copeland, were injured and taken to hospital, but no one was killed. Copeland had been at the store to give a grand opening speech. He helped evacuate the space and was credited with saving lives.

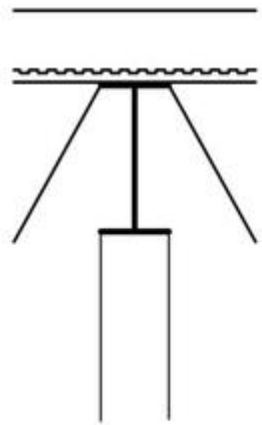
- Trevor Burkitt, a photographer, was able to take a picture of the broken pipe and severely distorted beam (Right)
- Cross Section of Column and Beam During Collapse (Left)

- Original Position

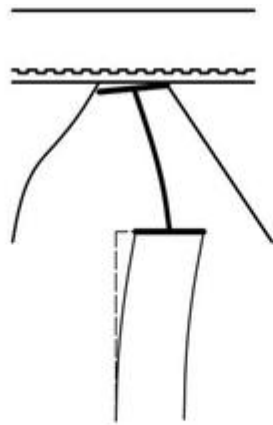
- Column head displaces laterally
- Lower beam flange yields
- Web begins to buckle
- Joists begin to disconnect

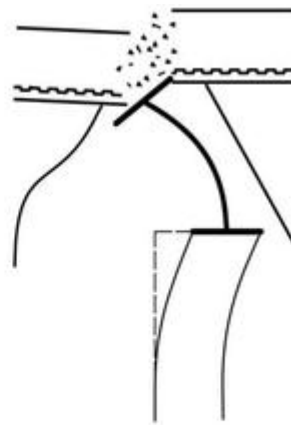
- Column head displacement increases
- Beam flange and web buckling continues
- Joists Fail
- Collapse immediate

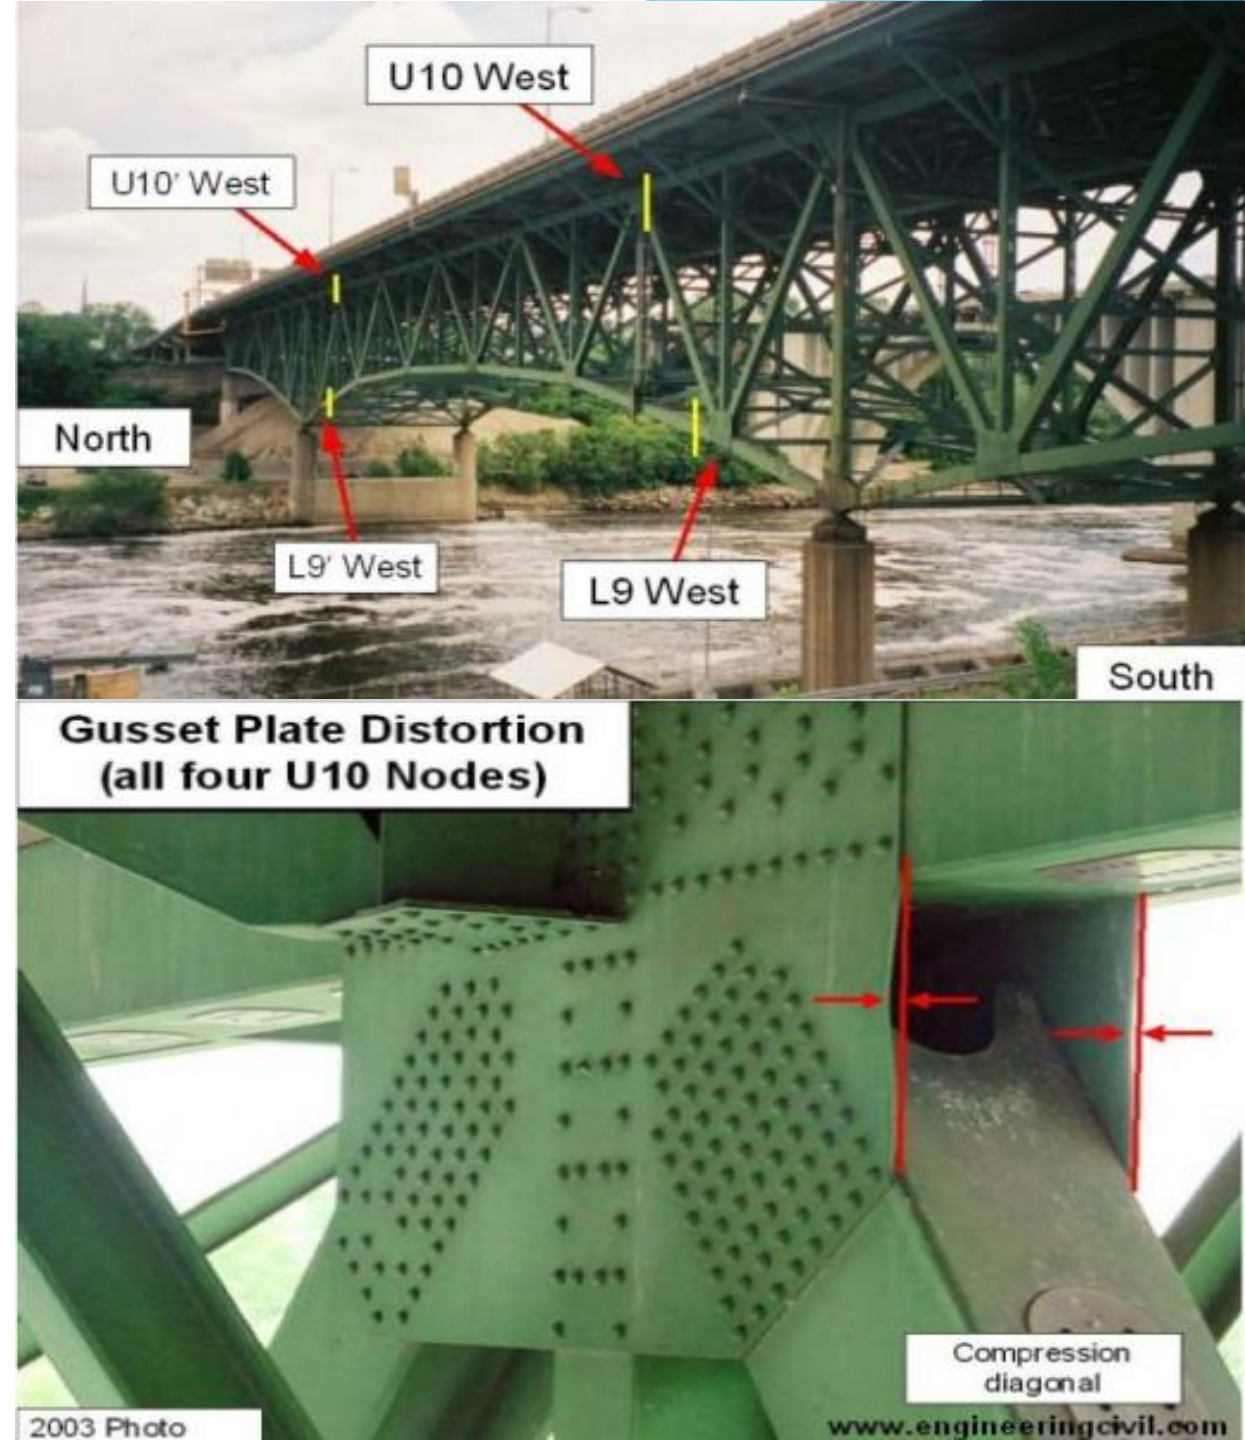
- ▶ Collapse: August 1, 2007 at 6:05 PM
- ▶ Cause: Under-Designed Gusset Plates
 - Sheets of steel used to connect truss members together
- ▶ Distortion was observed in the gusset plates during an inspection of the bridge in 2003
- ▶ *AASHTO Guide for Commonly Recognized Structural Elements* does not include gusset plates as a separate bridge inspection element

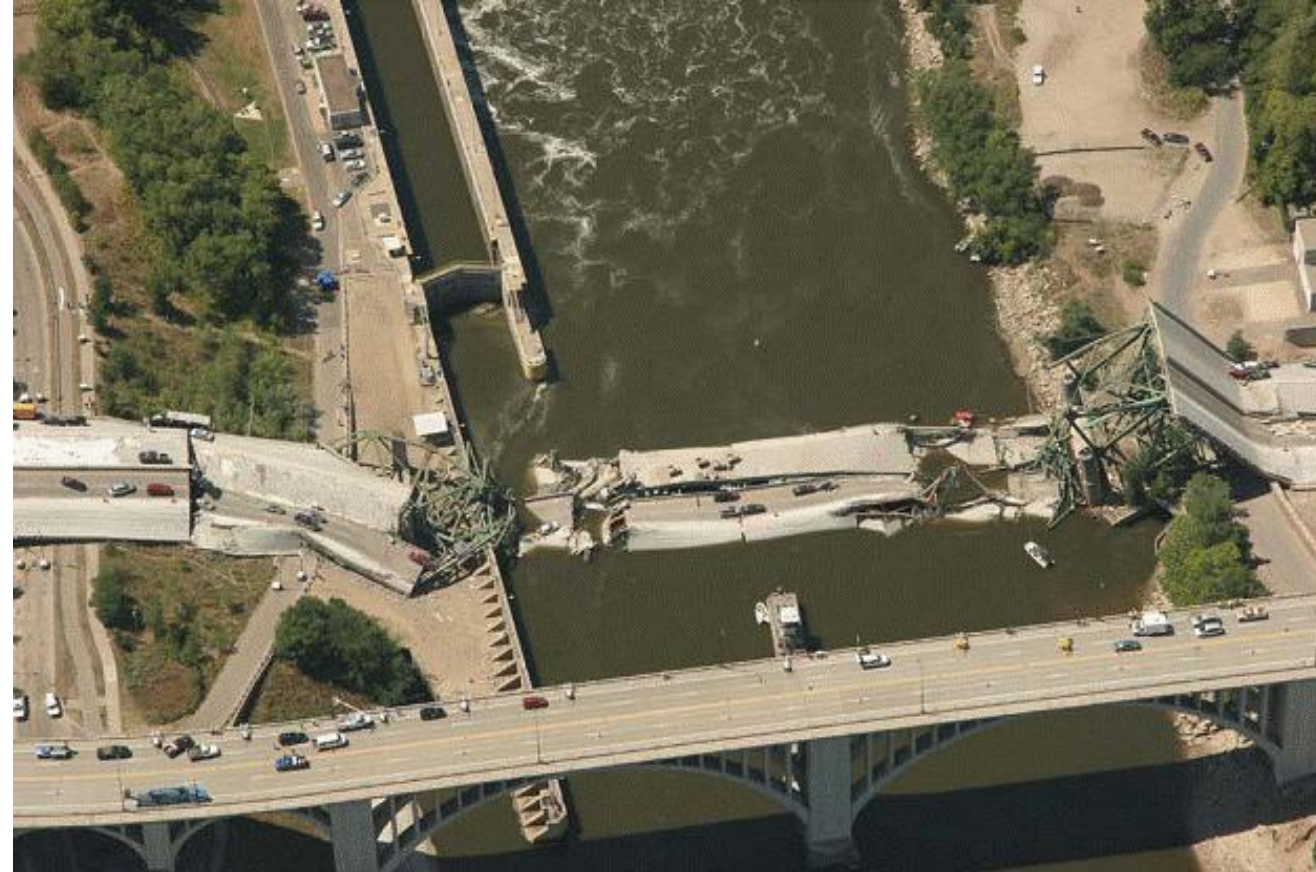
- ▶ High loads on the surface of the bridge
 - ▶ 2” of concrete had been added to the road deck
 - Increasing the weight of the bridge deck by 20%
 - ▶ Construction equipment and materials were on the bridge
 - 578,000 lbs. worth
- ▶ Even with these high loads, the bridge would not have collapsed had the gusset plates been the proper size
