GEOTECHNICAL ENGINEERING

Geotechnical Conditions Post Hurricanes

Intro to Infrastructure
Spring 2018

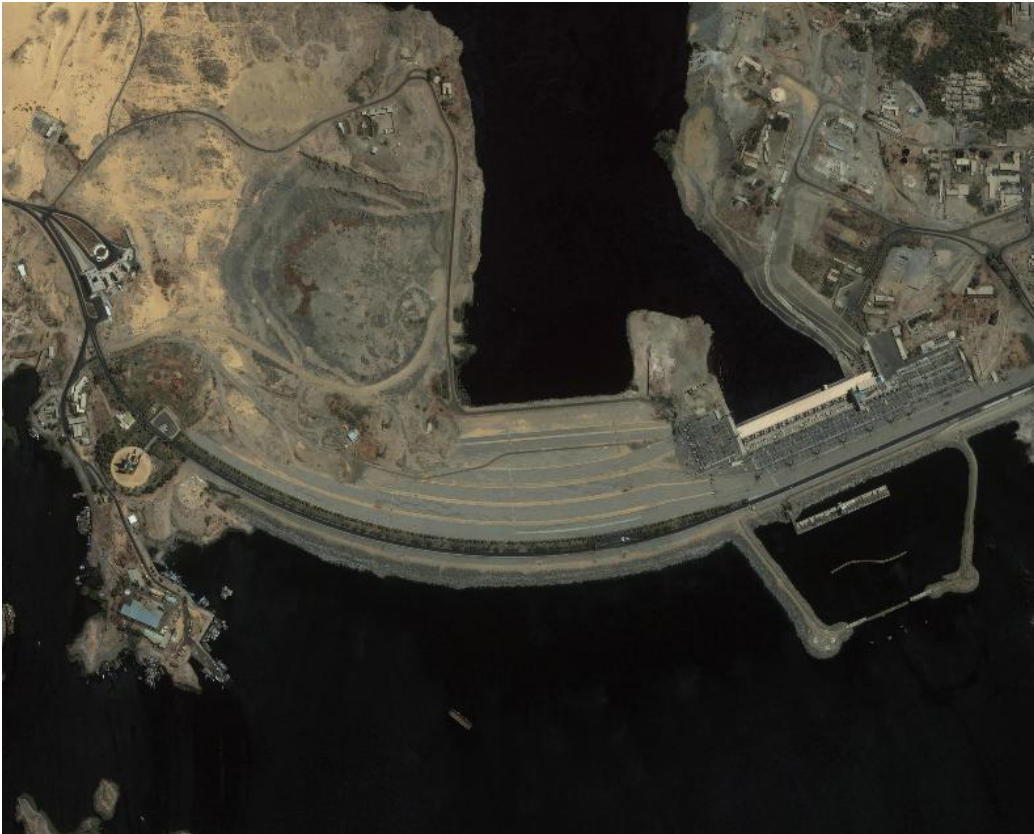
Satellite view of Aswan High Dam in Egypt. Completed in 1970, this gigantic dam was one of the **largest earthen embankment** dams in the world. It is 111 m tall, 3830 m long and nearly 1000 m wide. Its construction has had immeasurable impacts on the Egyptian economy by regulating the Nile river flooding, providing storage of water for agriculture and for generating electricity.

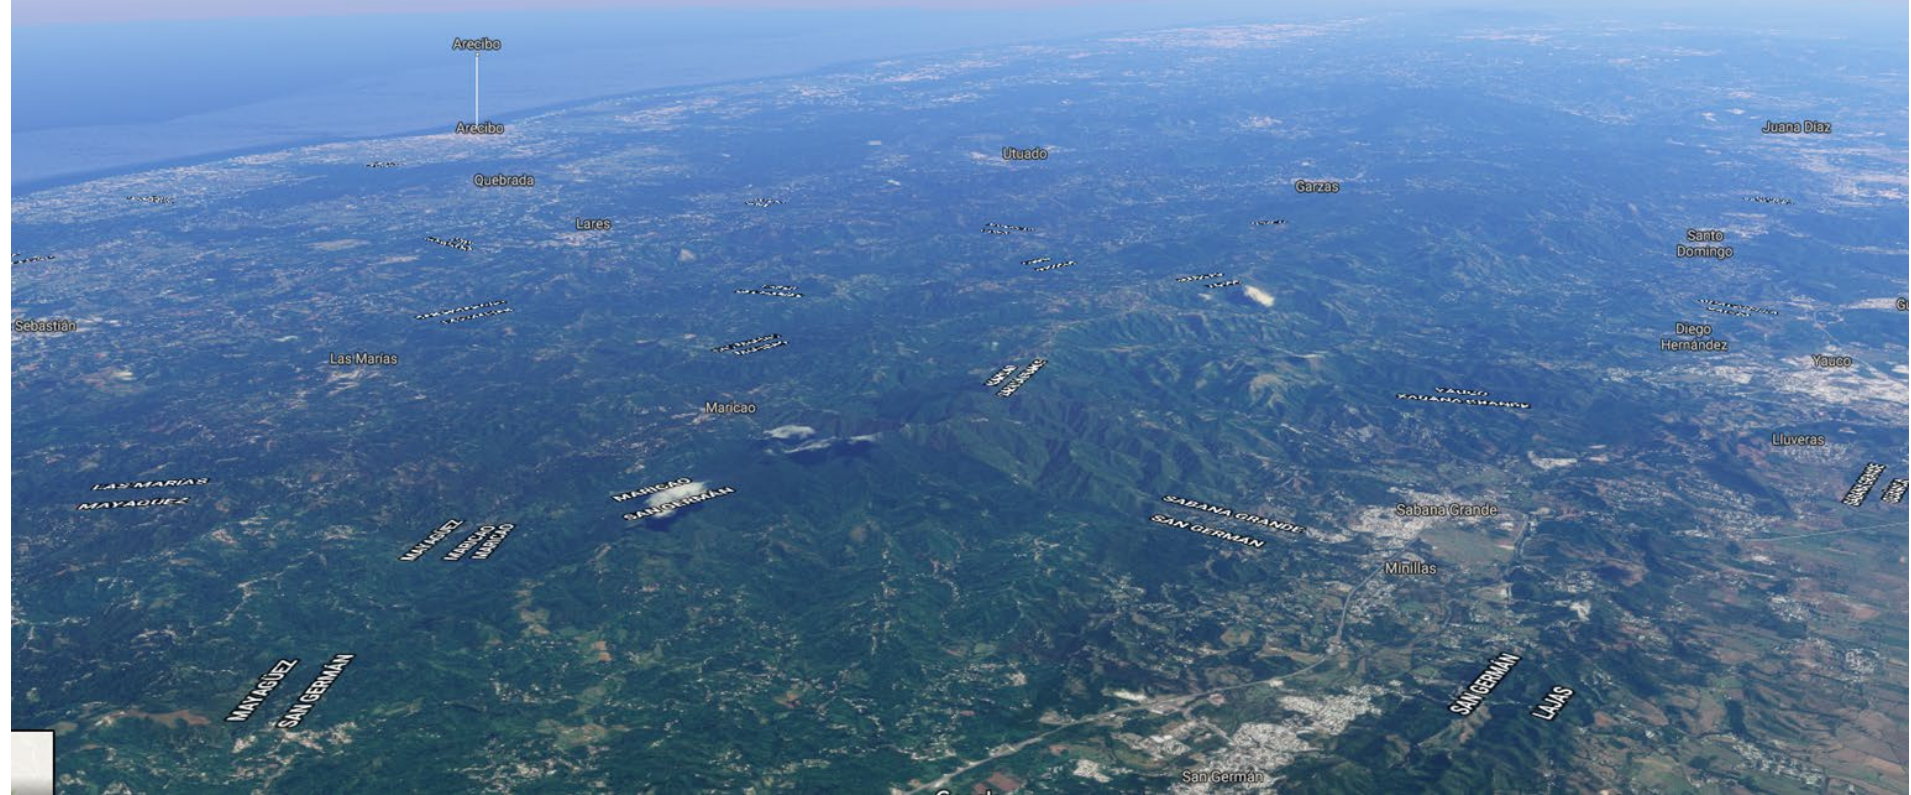
Elevation Display at the Center of the Island

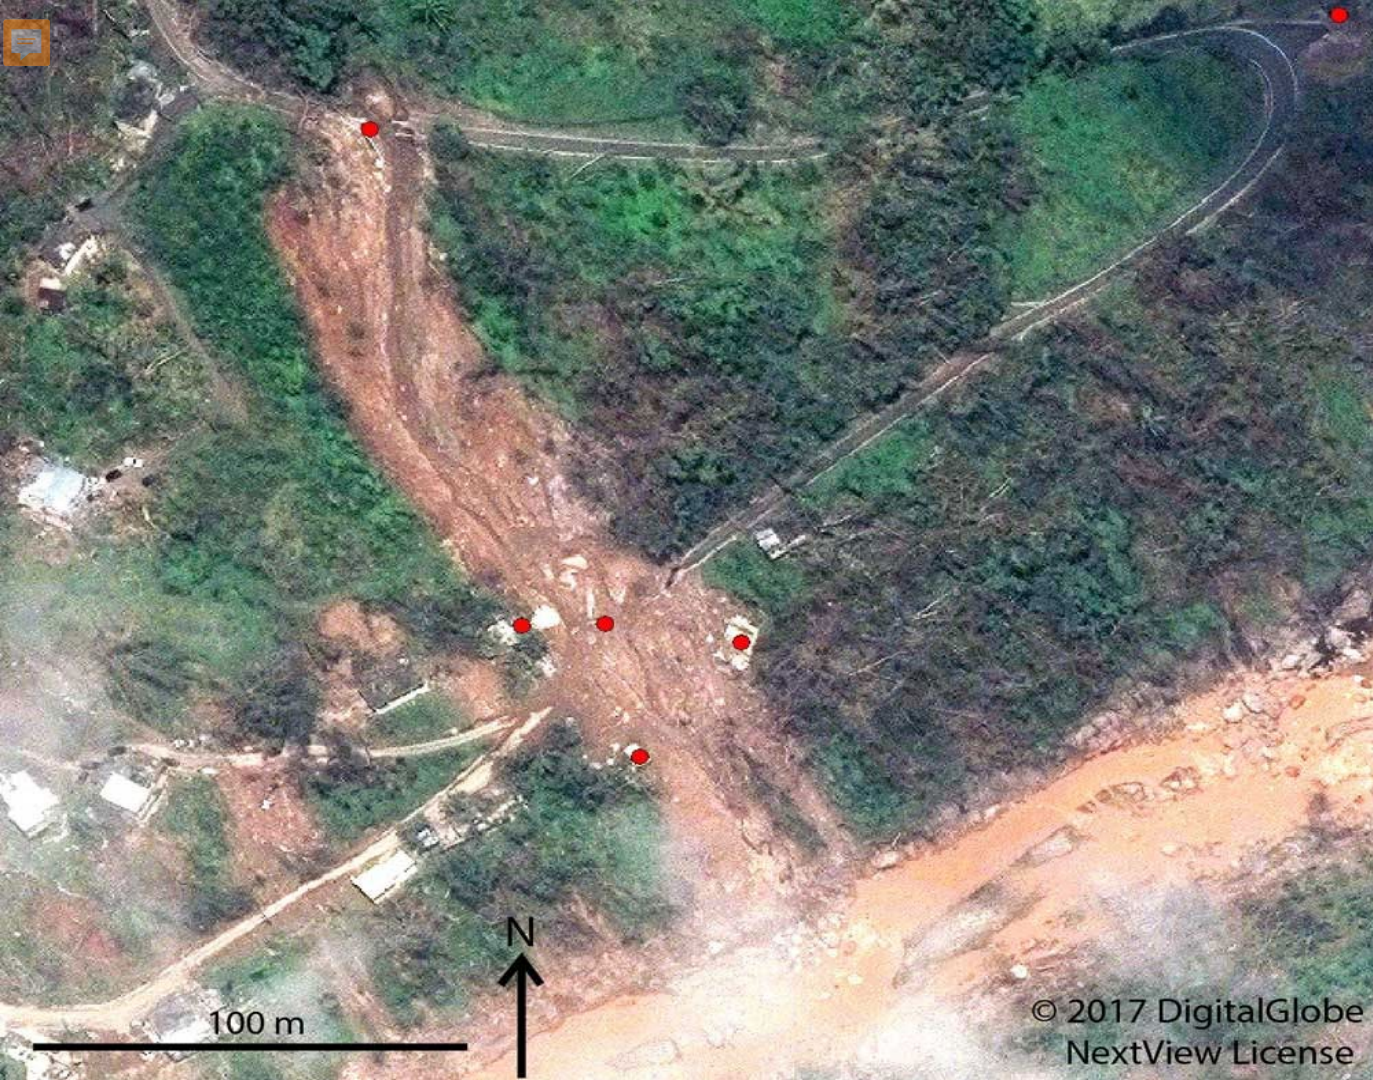
Road damaged by
Mudslides

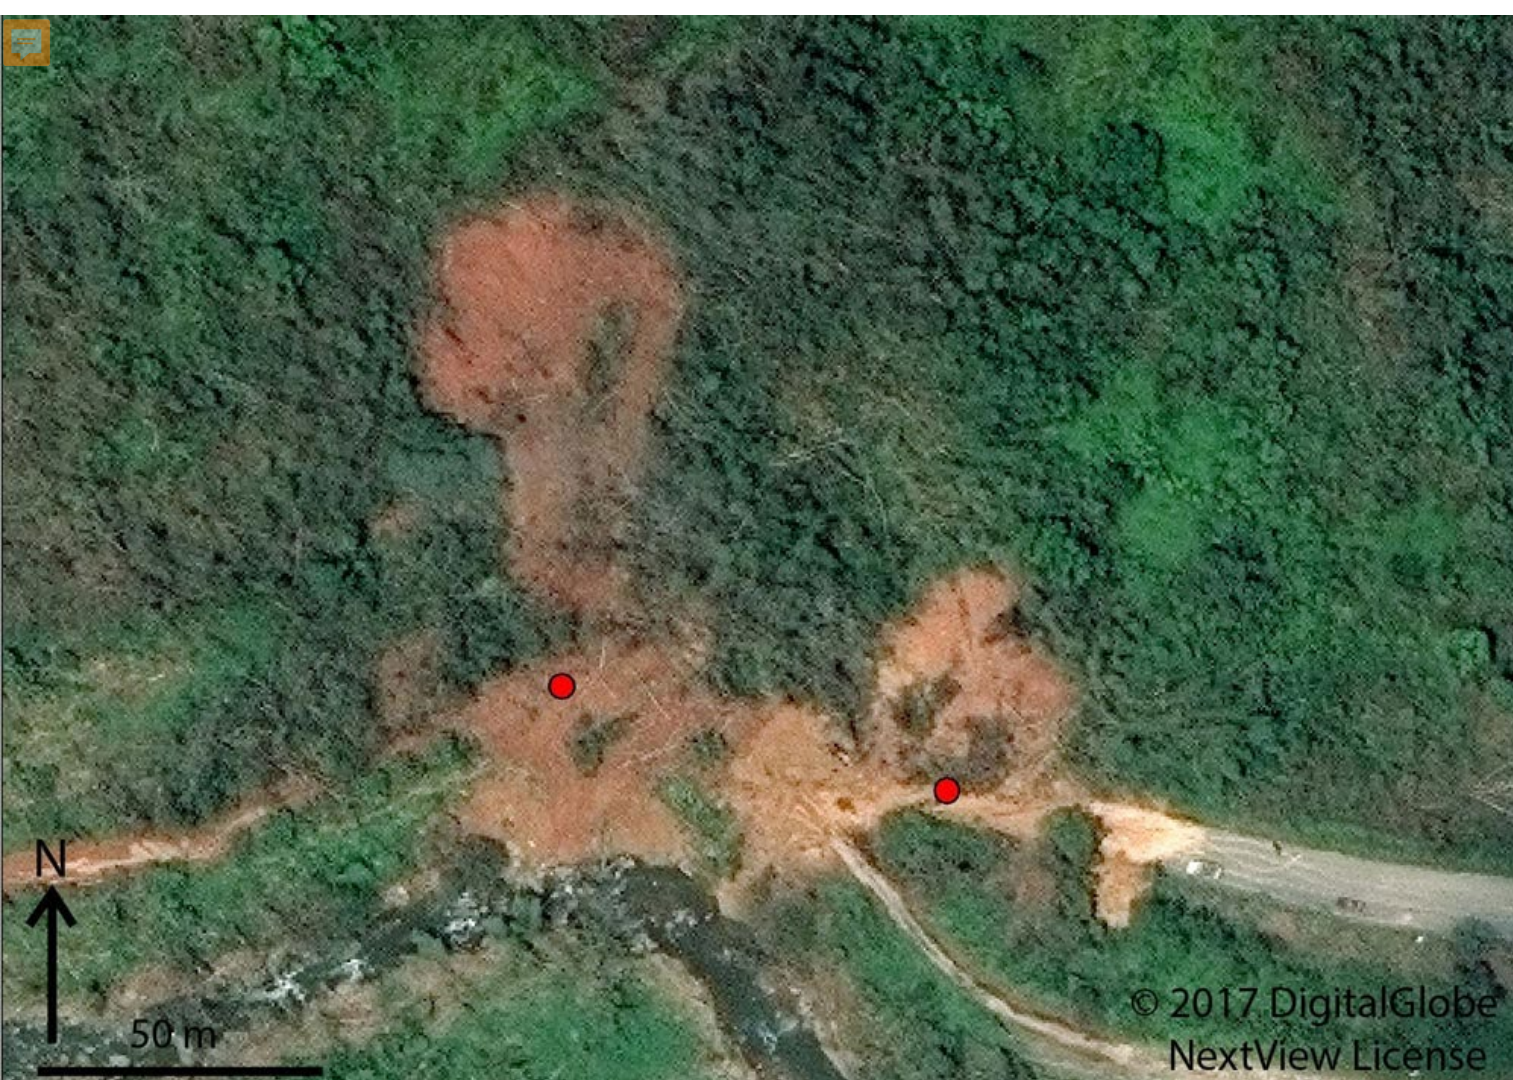
Landslide near Rio Rosario, Maricao Municipality.

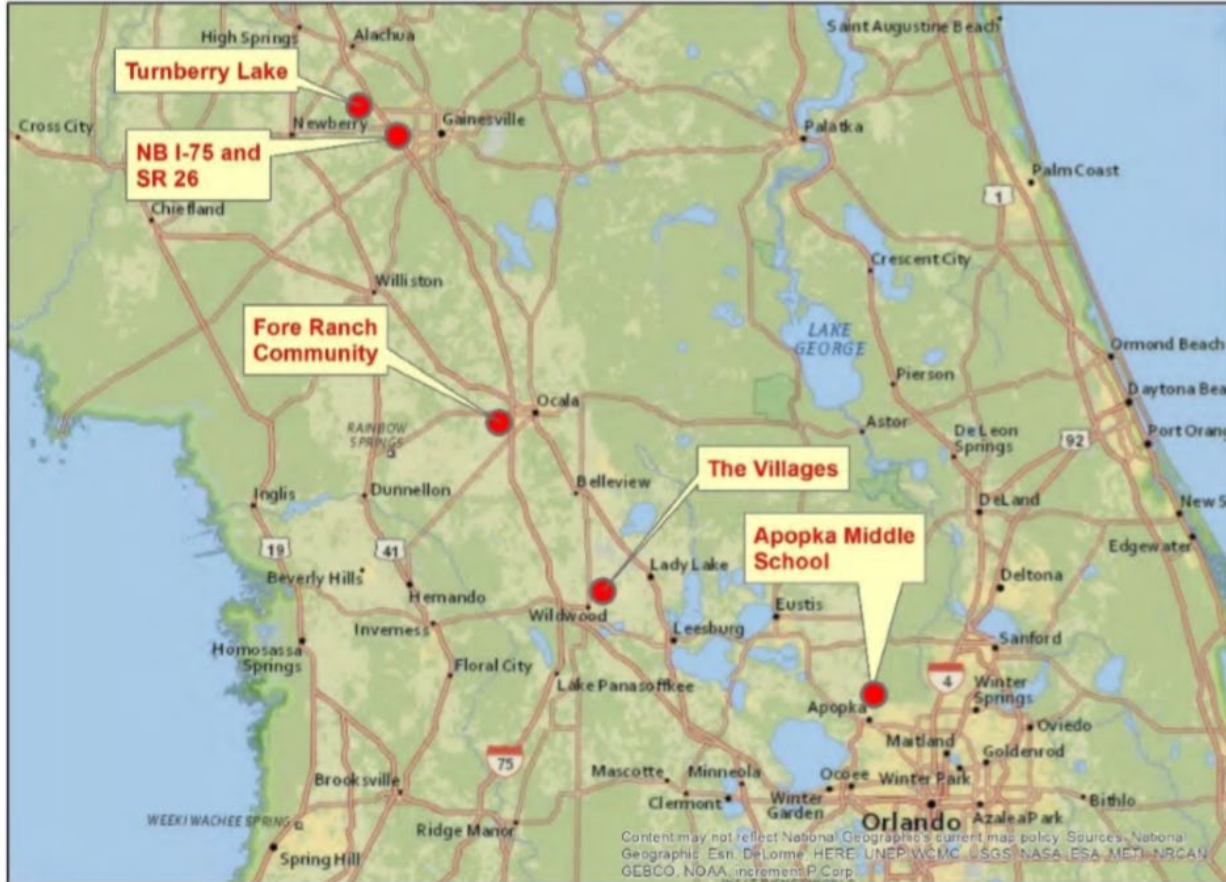
Locations that experienced sinkholes during Hurricane Irma at Central area of Florida

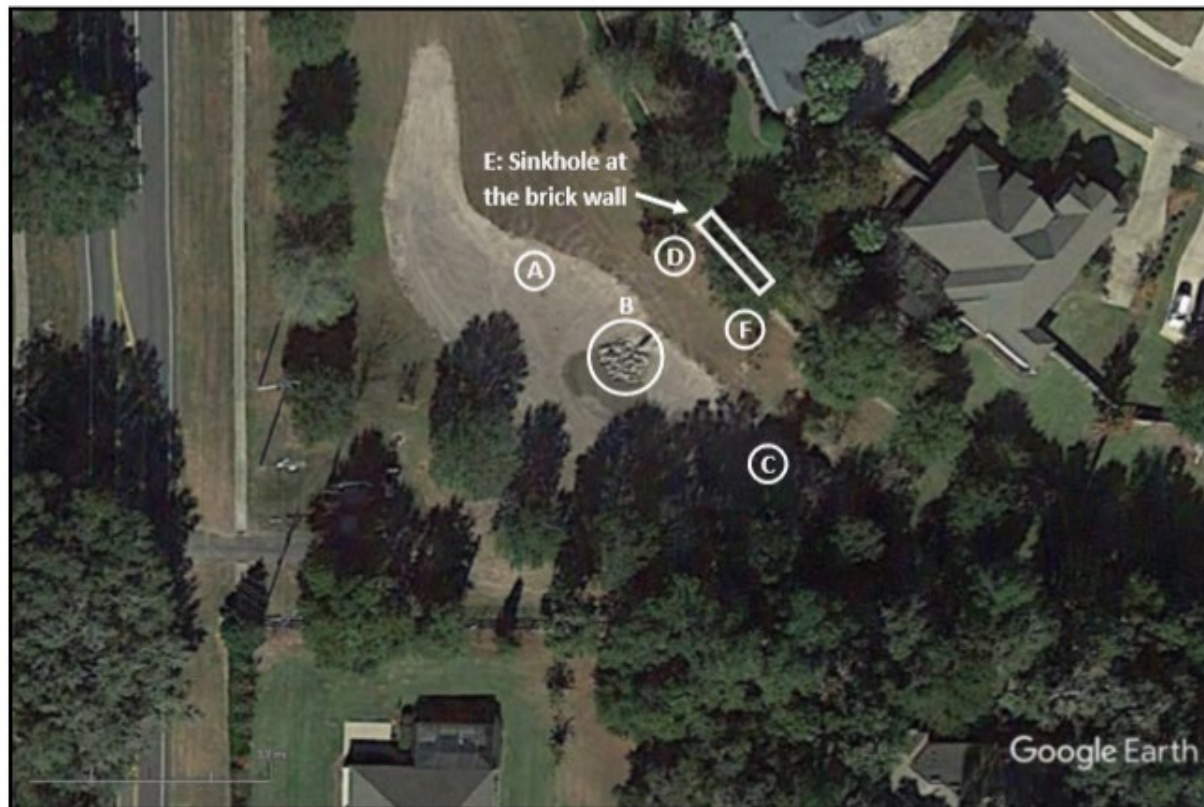
: Approximate locations of five sinkholes (A-E) and a depression (F) within and nearby a retention pond near 2800 NW 143 Street, Gainesville, FL (Latitude: 29°40'34.84"N / Longitude: 82°29'43.31"W) (from Google Earth, 2016).

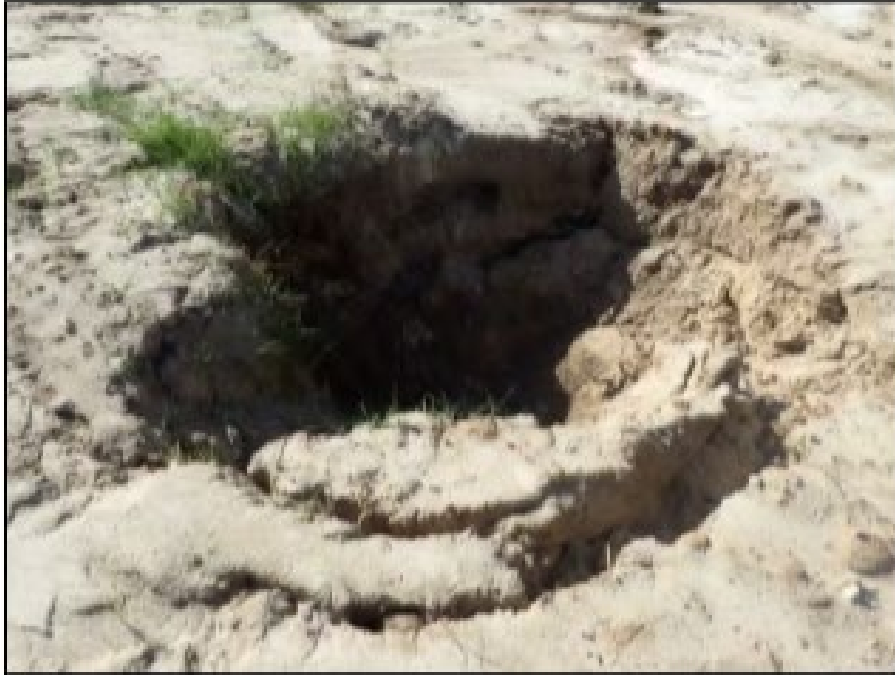
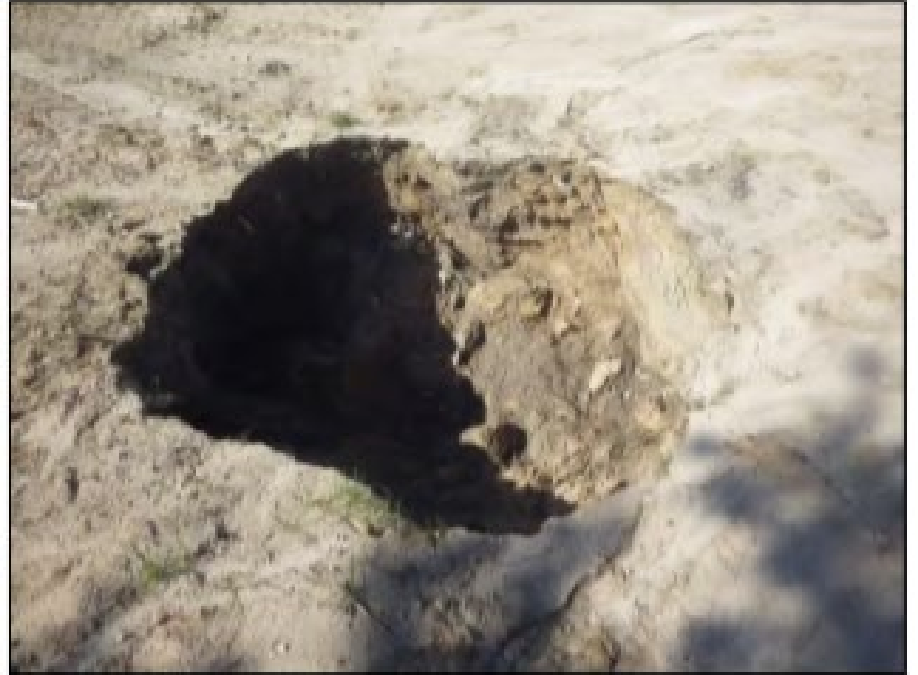
Sinkhole A (left) and sinkhole C (right)

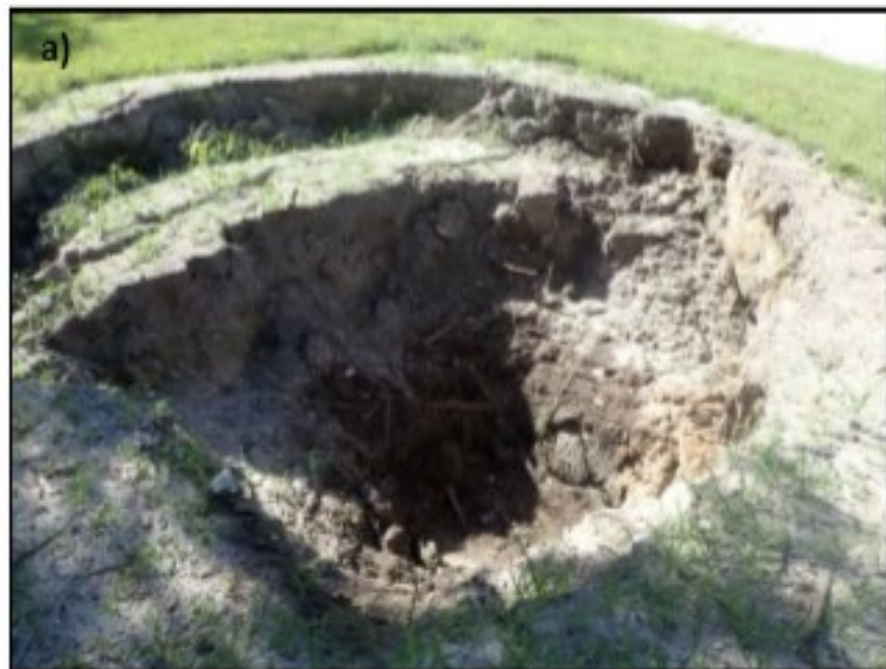
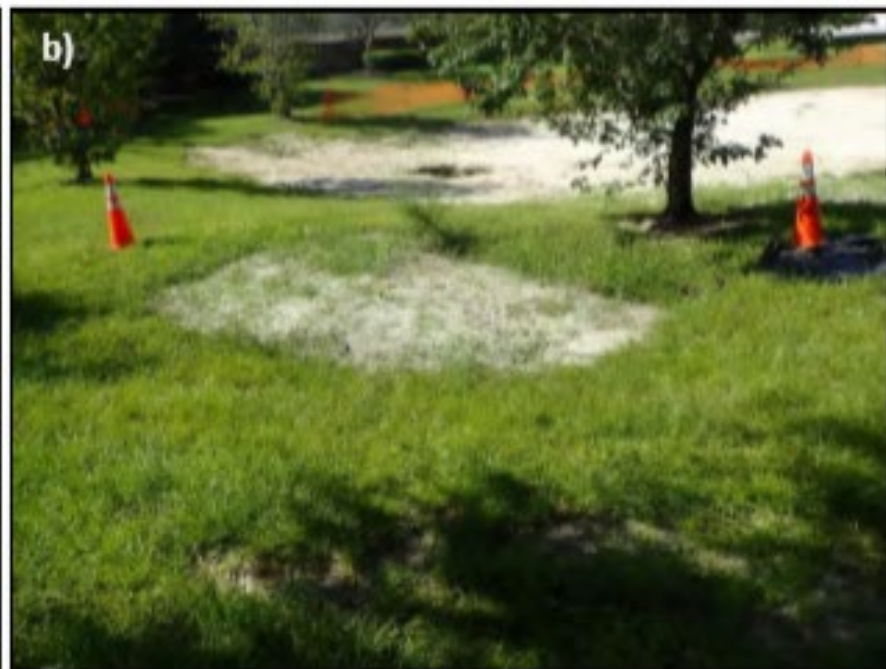
: a) Sinkhole "D" (Latitude $29^{\circ}40'48.85''\text{N}$ / Longitude: $82^{\circ}29'43.13''\text{W}$ and b) newly developed depression "F" (Latitude $29^{\circ}40'47.99''\text{N}$ / Longitude $82^{\circ}29'41.99''\text{W}$).

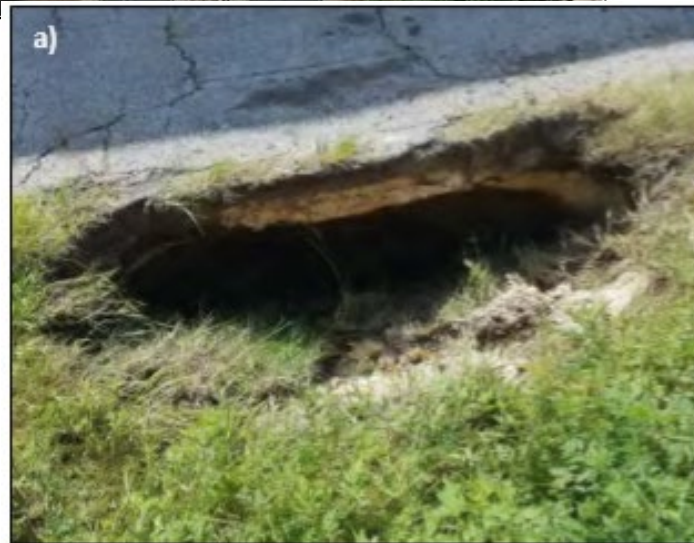
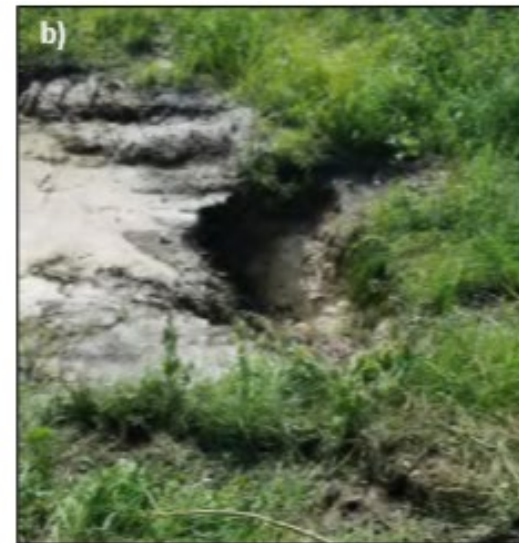
Sinkhole on the roadside on **South I-75 and SR-26** of central Florida which located in Gainesville.

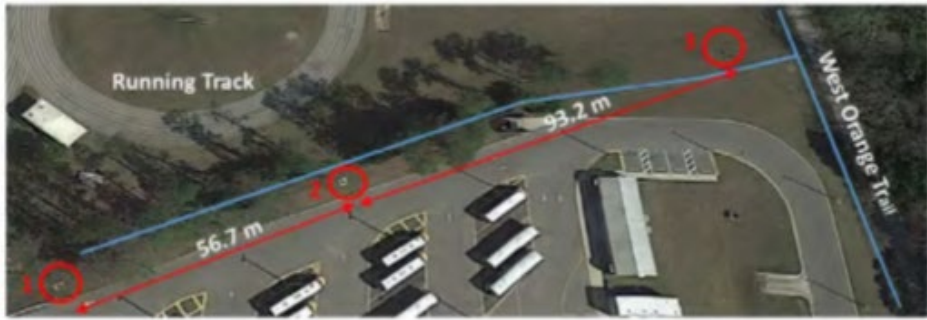
Apopka Middle school had experienced a massive erosion on the south end of the school property between the run track and the school bus parking area.

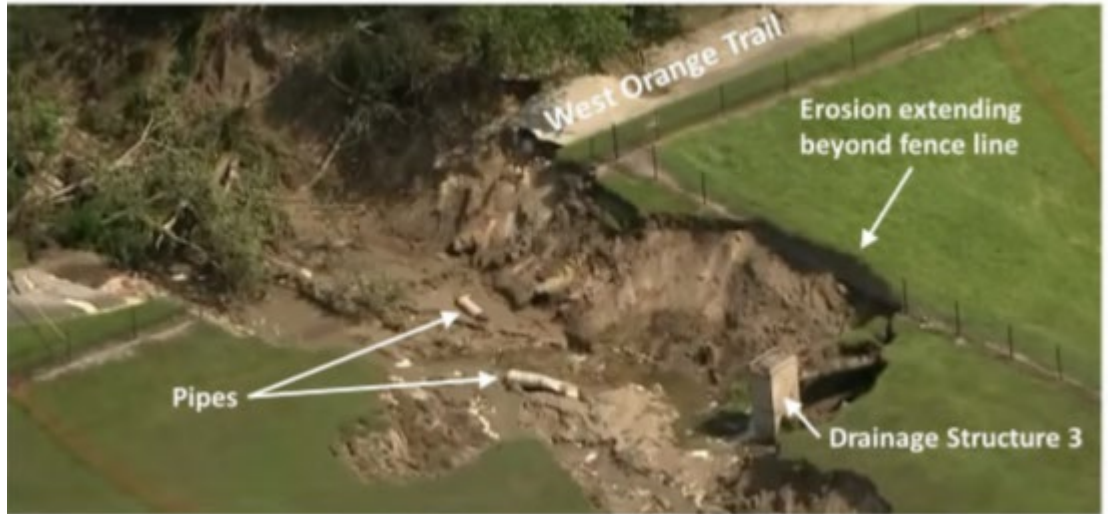
The erosion washout at the drainage structure 3 as shown above ended up with the erosion from western extent to the West Orange trail and damage two of the large scale drainage structures which was built to support the drainage of the parking area.

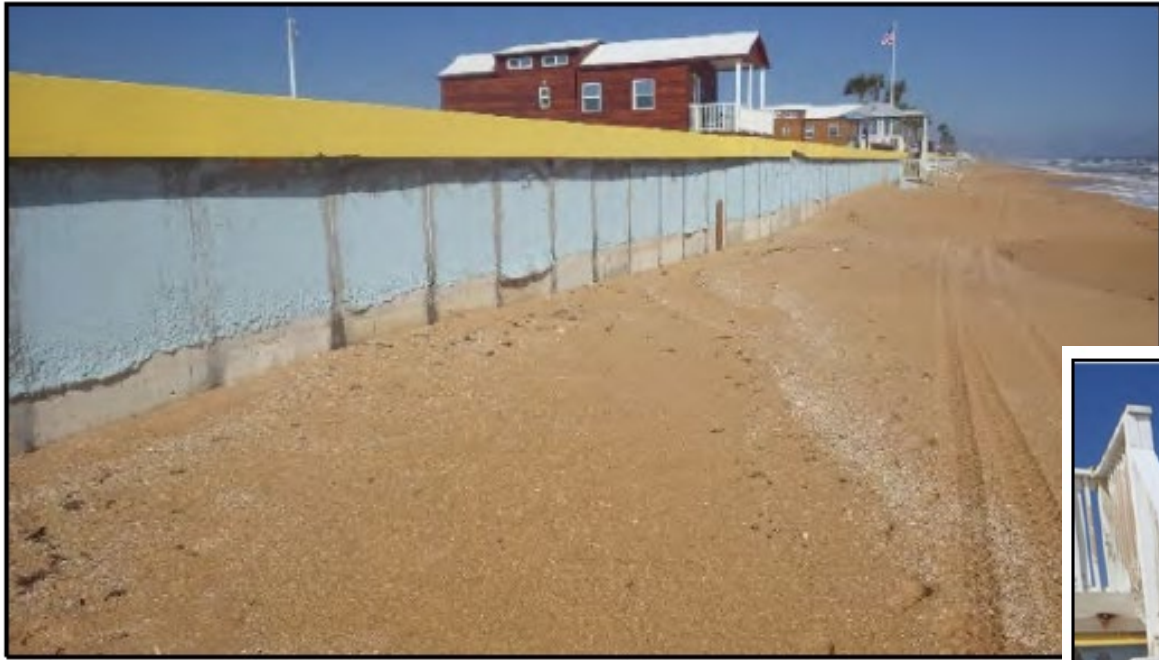
Erosion and scour at Beverly Beach, Flagler County.

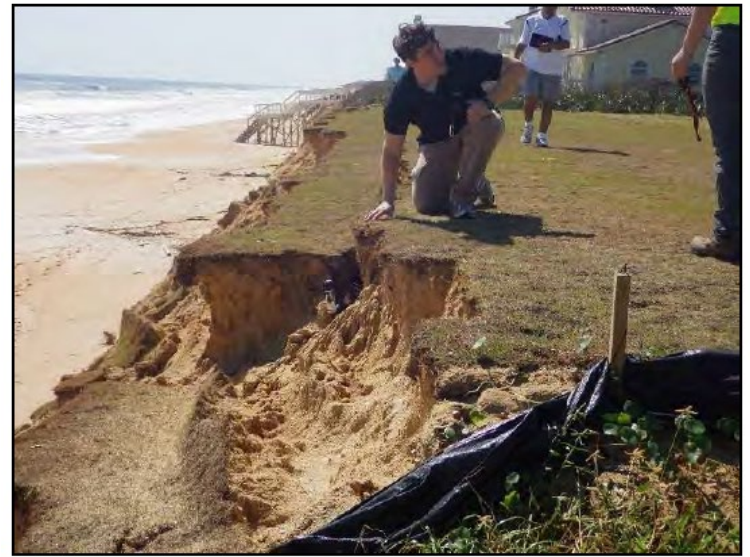
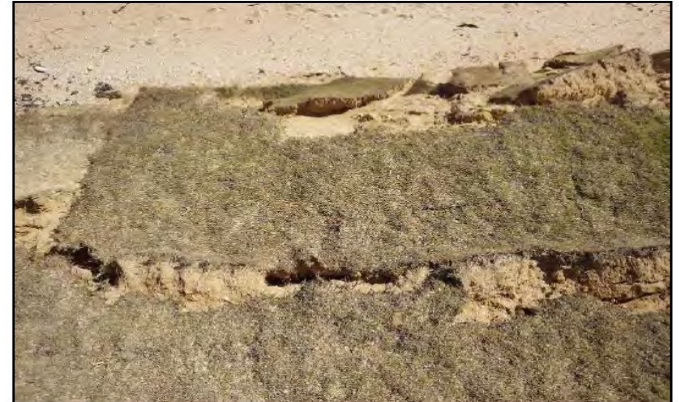
A large dune was eroded during the hurricane at the Ocean Shore Boulevard of Painters Hill,

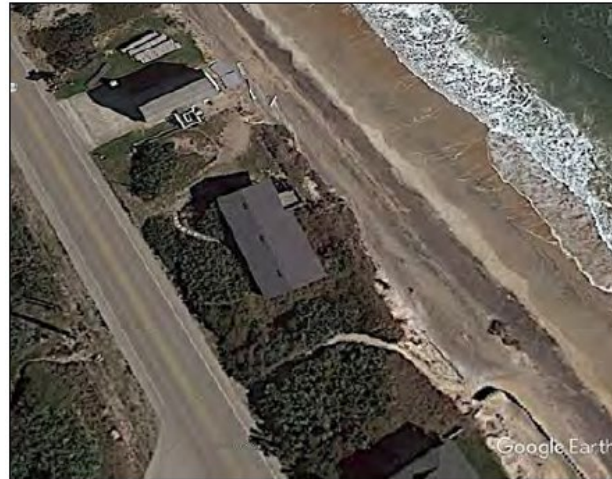
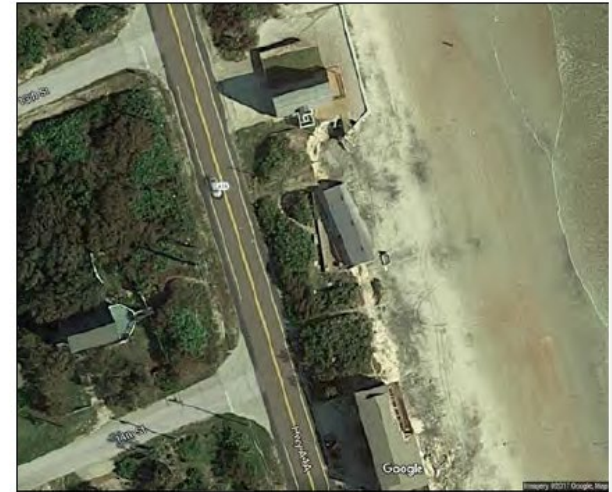
The Breach side, 1.7 km away from the Marineland, experienced some serious scour during the event.

A residential house was collapsed because of the erosion of the dune system along the Coastal Highway in Vilano Beach.

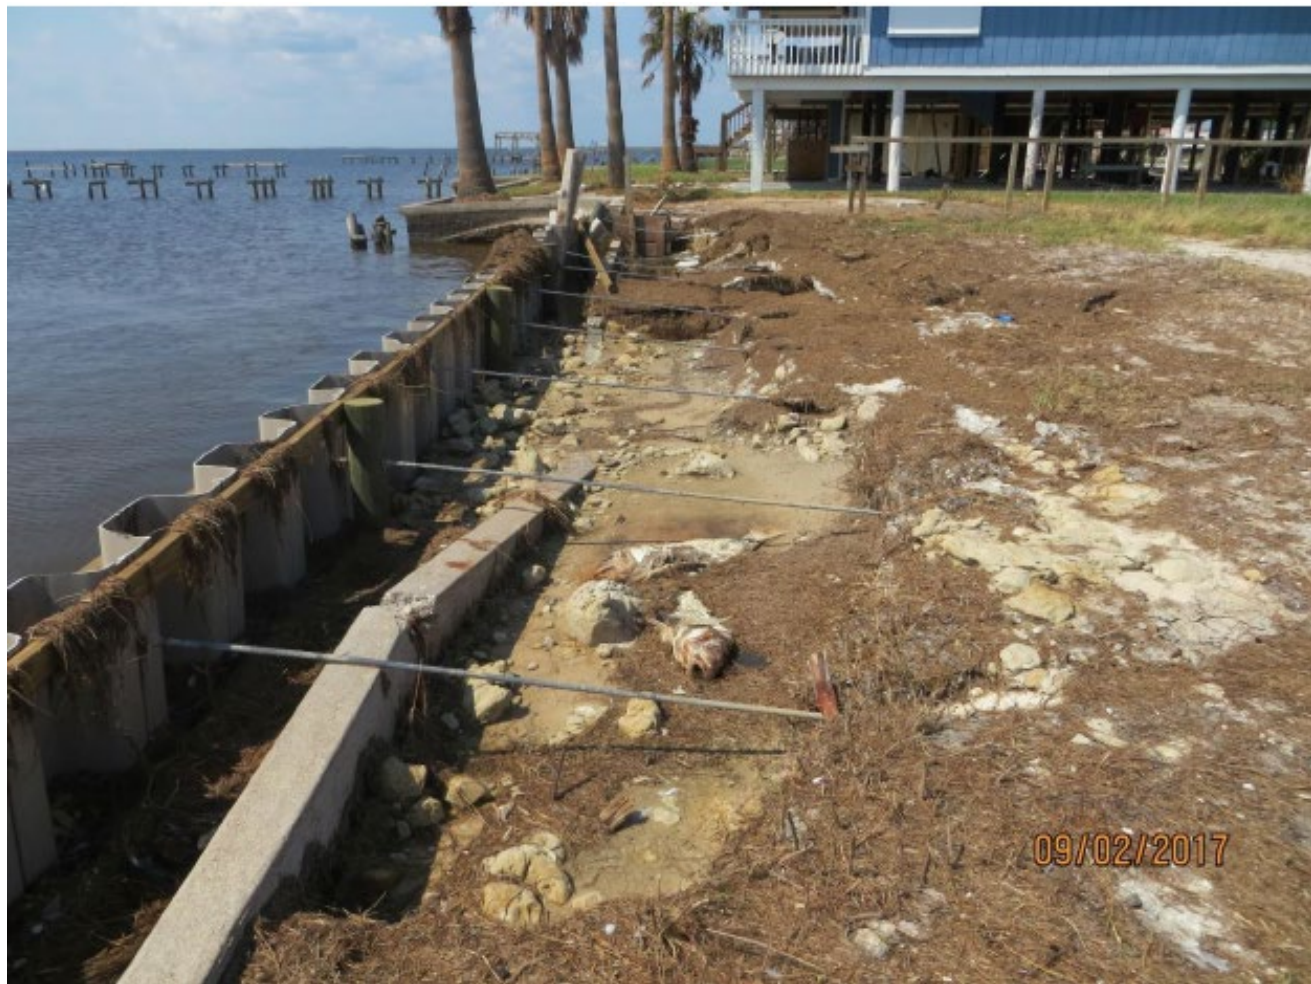
The east bank of the Colorado River was eroded considerably seemingly at the time of the flood. The flood apparently caused significant damage to the sheet pile wall on the upland of the east bank.

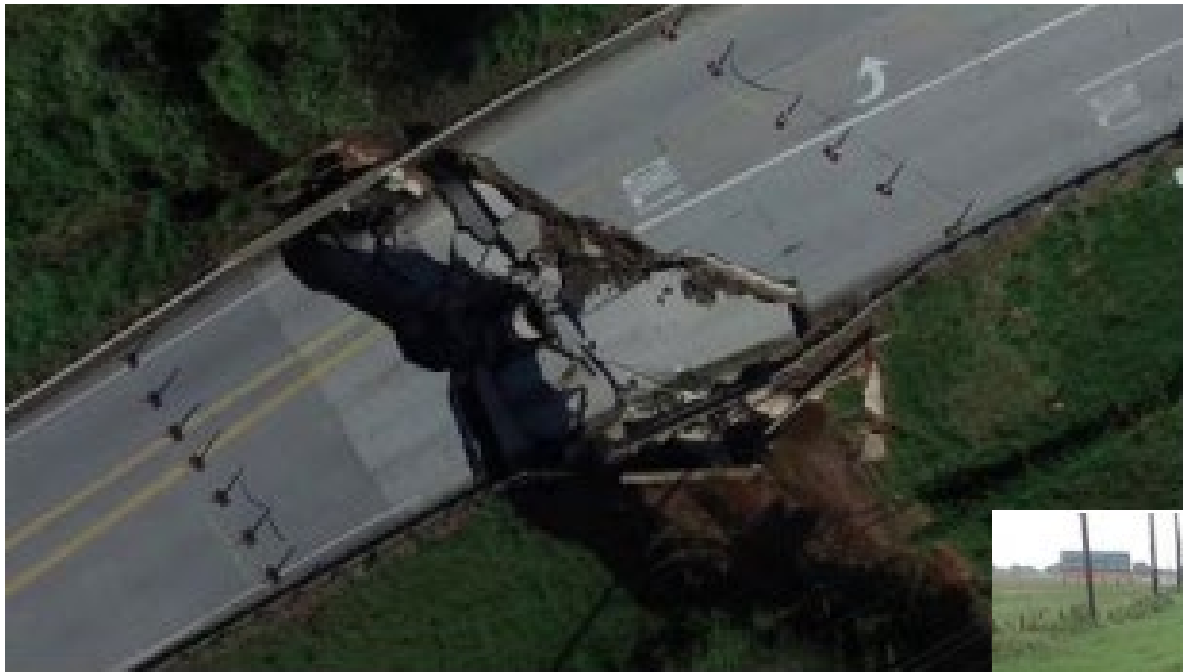
Damage of the walkway slab on Beltway 8 (left photo courtesy a resident in the area, August 27, 2017, and right photo courtesy of a construction worker on site

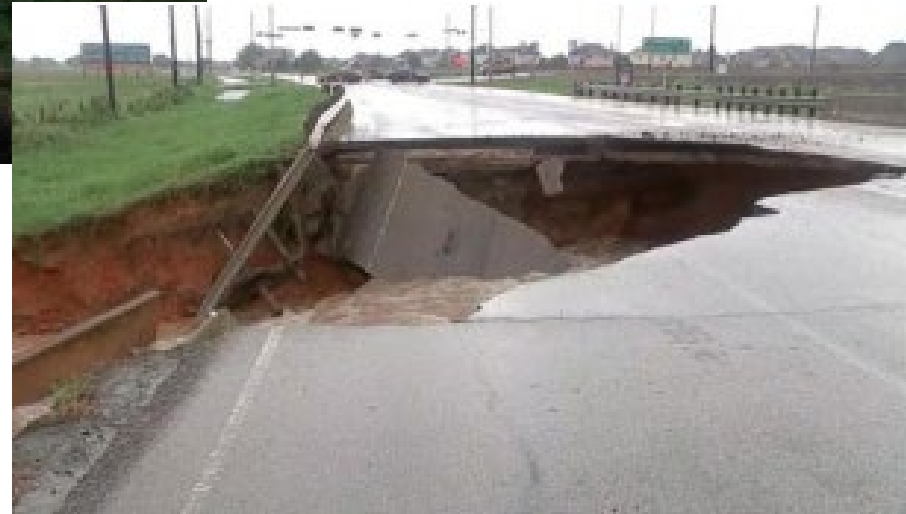
The fast moving flood seemingly caused significant erosion in the culvert foundation, and consequently led to the culvert bridge failure.
